November 2002, ver. 2.2

Errata Sheet

This errata sheet provides updated information on Stratix[™] engineering sample (ES) devices. Altera has identified four silicon issues affecting these devices. This document addresses the issues and includes methods to work around the issues.

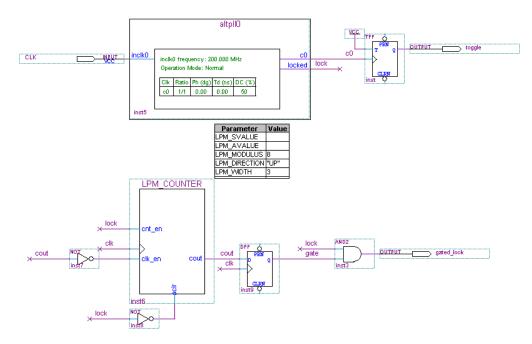
Figure 2. Gated Lock in Internal Logic Circuit

There is a run-through problem in the GLOCK counter that causes the counter to operate incorrectly. Support for the gated lock circuitry was disabled in the Quartus II software version 2.1. Therefore, the gated lock feature is unavailable in Stratix devices.

The work around for this problem is to gate the lock signal in internal logic. Altera recommends using a two-input AND gate to gate the lock signal with a counter. The counter determines how many clock cycles before the lock signal is released. See Figure 2.

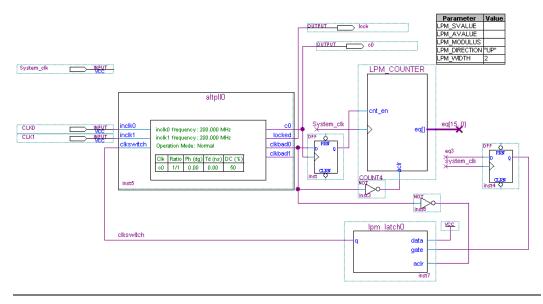
Figure 4. Clock Switchover Circuit

The CLKBAD0 and CLKBAD1 signals have a design flaw that causes a glitch in the signals. The glitches last for a half clock cycle. CLKBAD0 and CLKBAD1 are available for designers to use to control switchover internally.

To work around this issue, the designer should implement the circuit shown in Figure 4 to monitor the CLKBAD signal of the primary clock and initiate a switchover when the primary clock fails. The CLKBAD signal must be high for four clock cycles (the two-bit counter reaches four) before the circuit switches to the secondary clock. The counter will be cleared if there is a glitch in the CLKBAD signal it goes low in error before the counter reaches four. The CLKBAD signal is registered before driving the counter's cnt_en signal to prevent metastability. The clkswitch signal is latched so that it will only trigger a switch from the primary clock to the secondary clock.

In the circuit shown in Figure 4, CLK0 is the primary clock and CLK1 is the secondary clock. The circuit monitors the CLKBAD0 signal to determine when the clock driving CLK0 is lost.
